Concentrated Animal Feed Operation Inspection

Ottawa Holsteins, L.L.C.

October 19, 2017

**SUBJECT:** Concentrated Animal Feeding Operation, Follow-up inspection, Ottawa Holsteins, L.L.C., Ottawa, Ohio

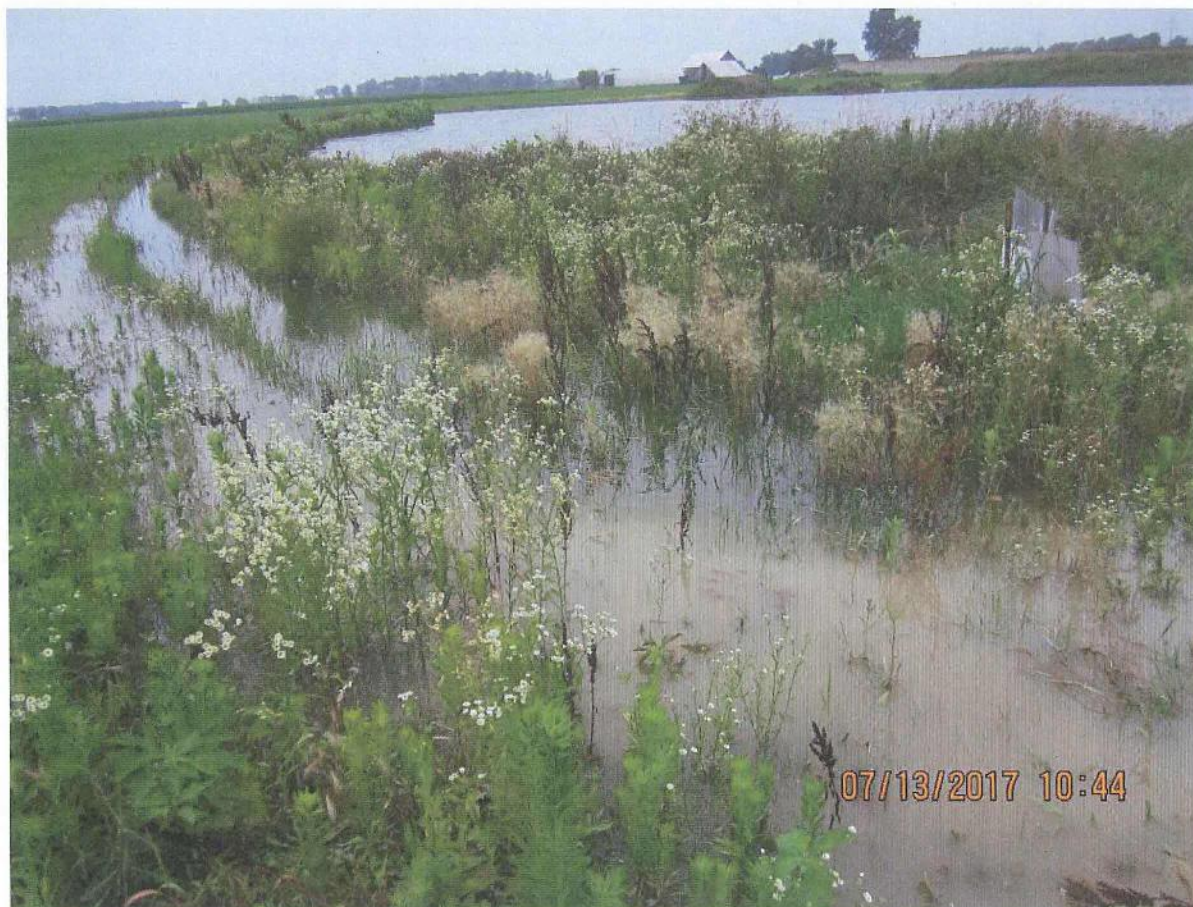
Photograph 1 of 14. Looking southerly at overflow from contaminated storm water pond (on right) going into swale that flows south into field. JM, 07/13/17, 1044 hrs., Cannon PowerShot SD1400IS, Ser. No. 212065043412, digital media.

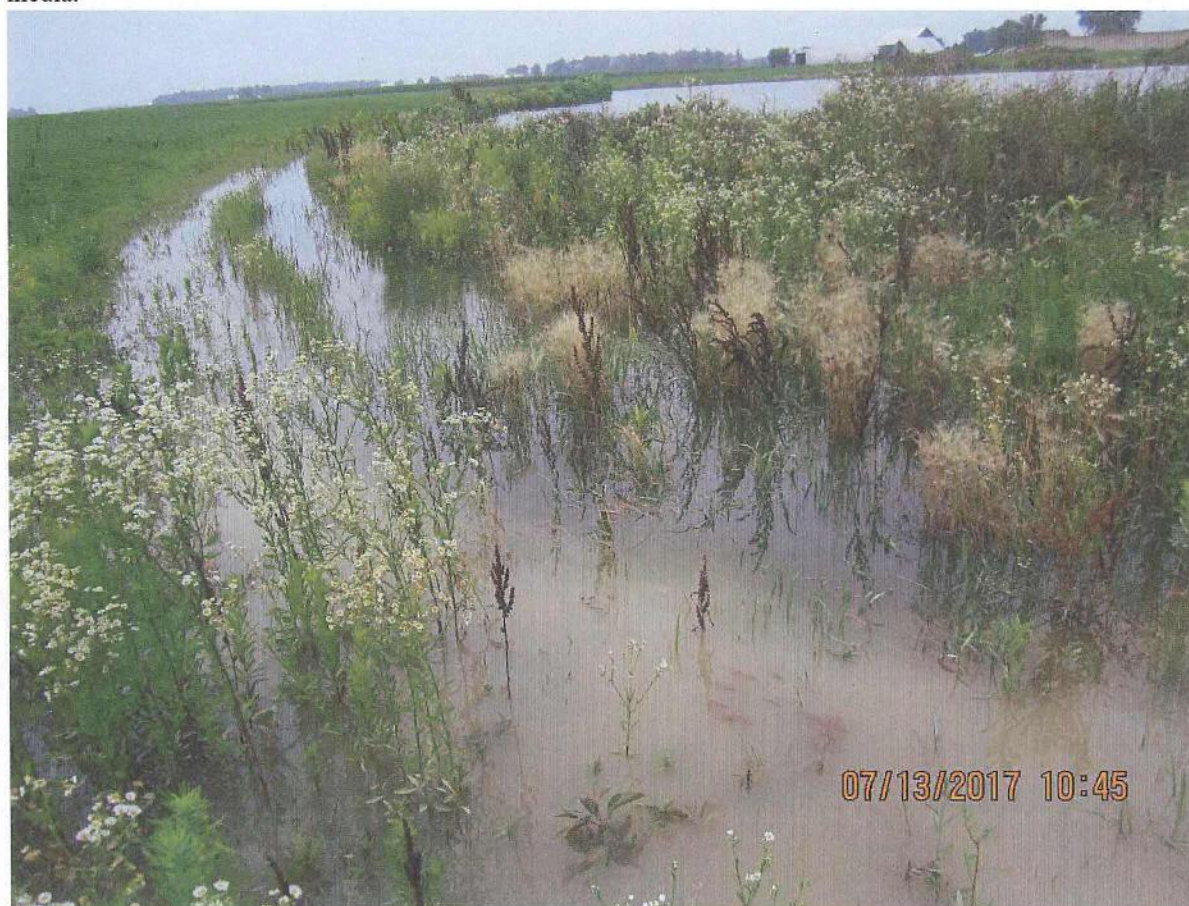
Photograph 2 of 14. Looking southerly at overflow from contaminated storm water pond (on right) going into swale that flows south into field. JM, 07/13/17, 1045 hrs., Cannon PowerShot SD1400IS, Ser. No. 212065043412, digital media.

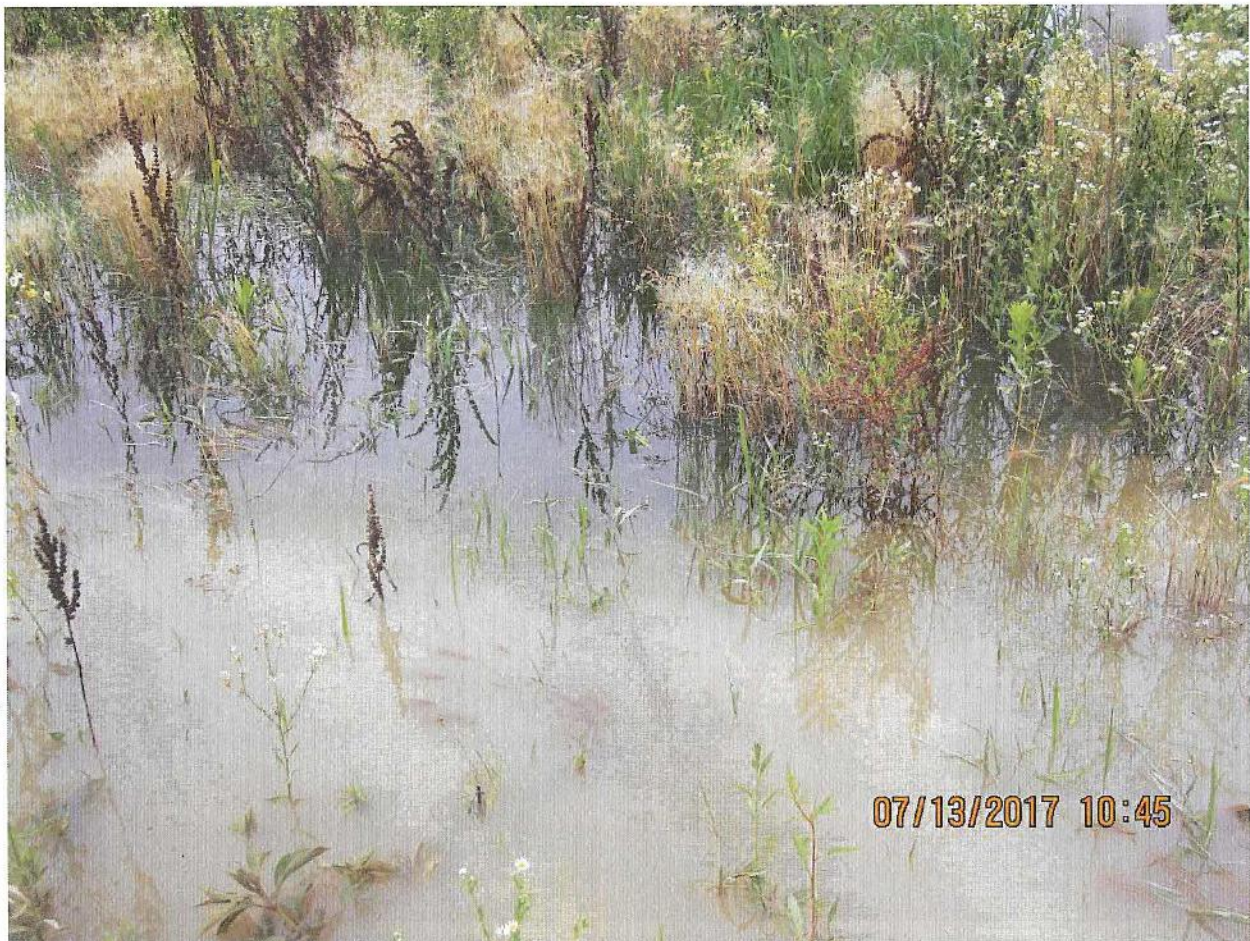
Photograph 3 of 14. Mixing of water from contaminated storm water pond and ditch. JM, 07/13/17, 1045 hrs., Cannon PowerShot SD1400IS, Ser. No. 212065043412, digital media.

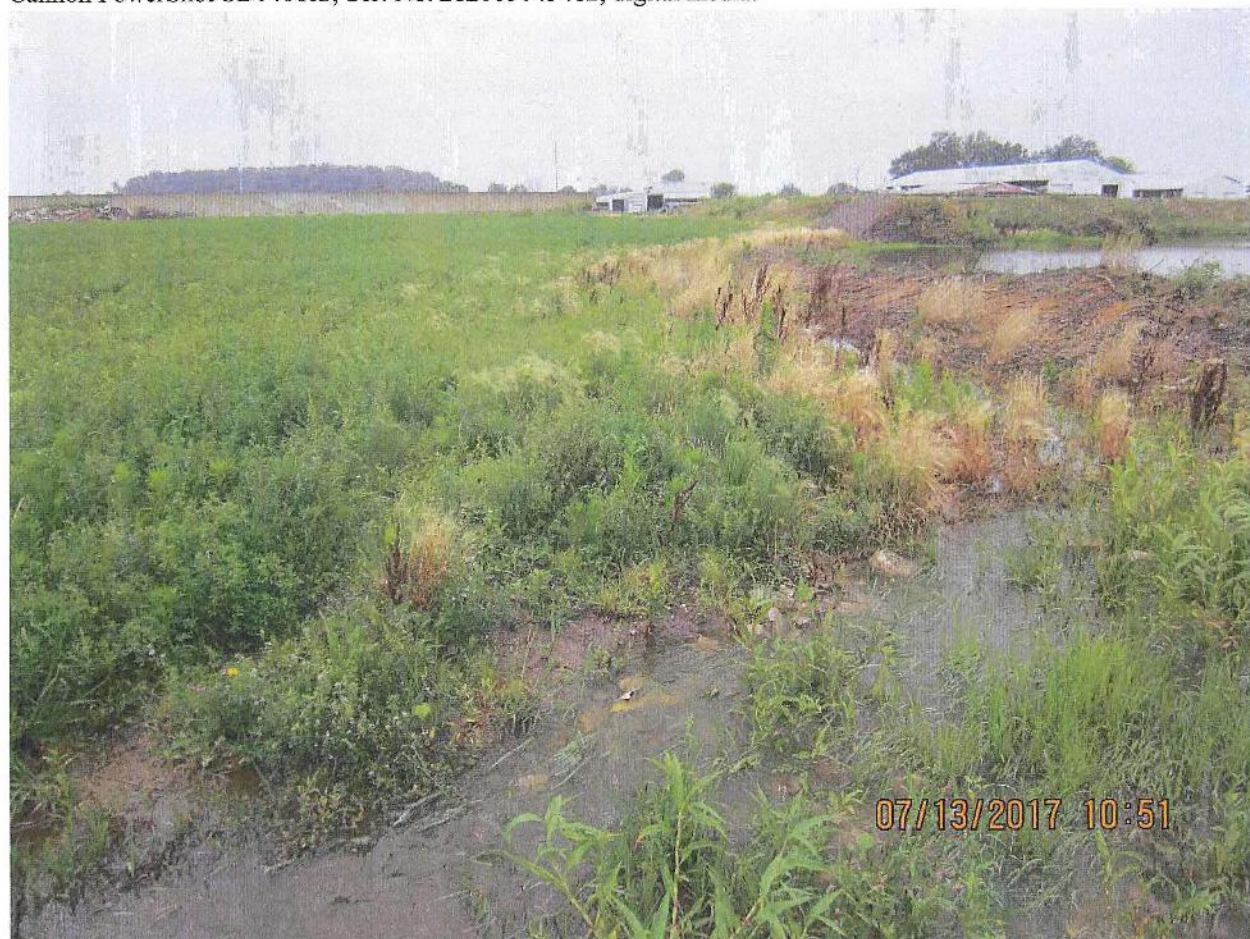
Photograph 4 of 14. Storm water ditch on east side of contaminated storm water pond. JM, 07/13/17, 1051 hrs., Cannon PowerShot SD1400IS, Ser. No. 212065043412, digital media.

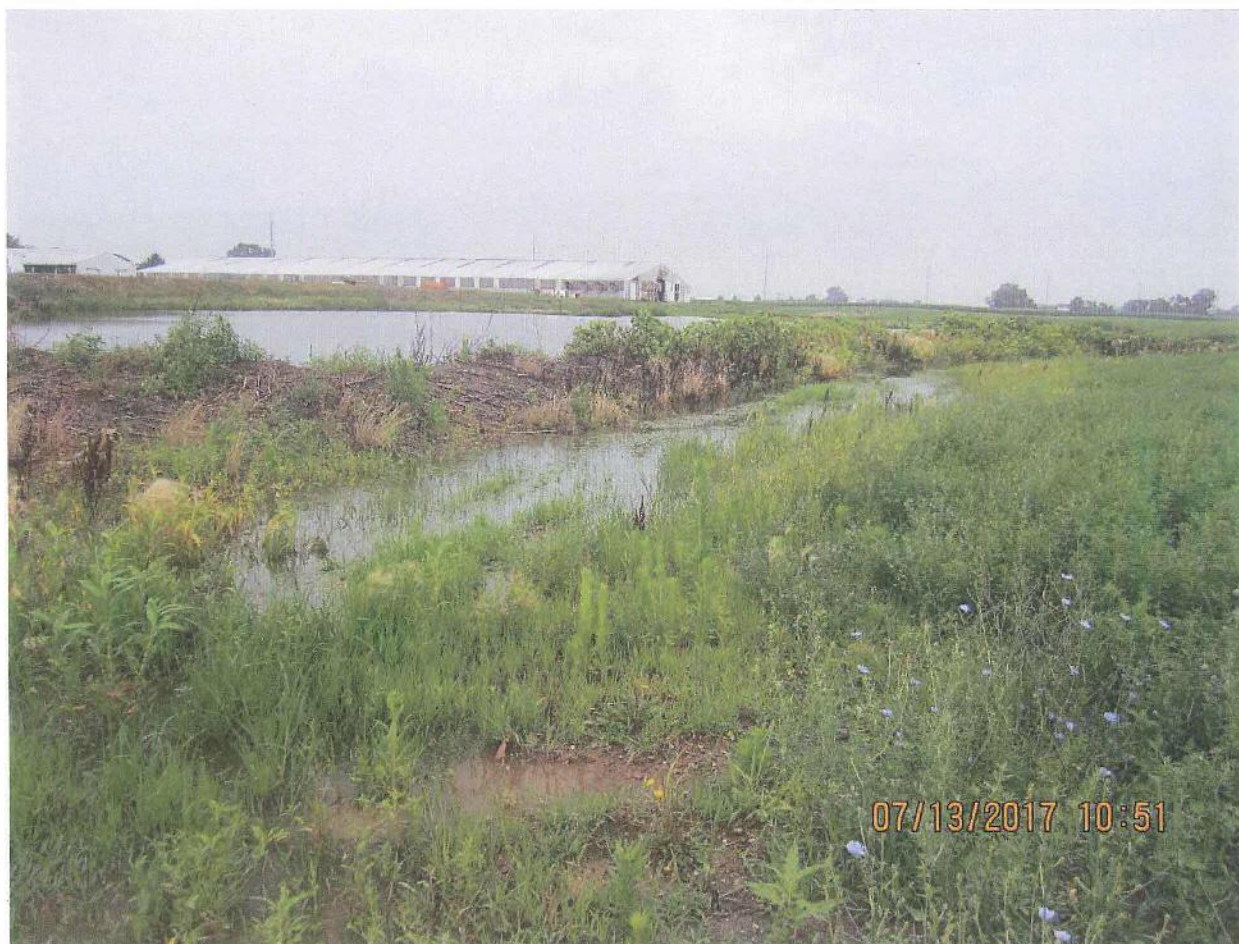
Photograph 5 of 14. Storm water ditch on east side of contaminated storm water pond looking north. JM, 07/13/17, 1051 hrs., Cannon PowerShot SD1400IS, Ser. No. 212065043412, digital media.

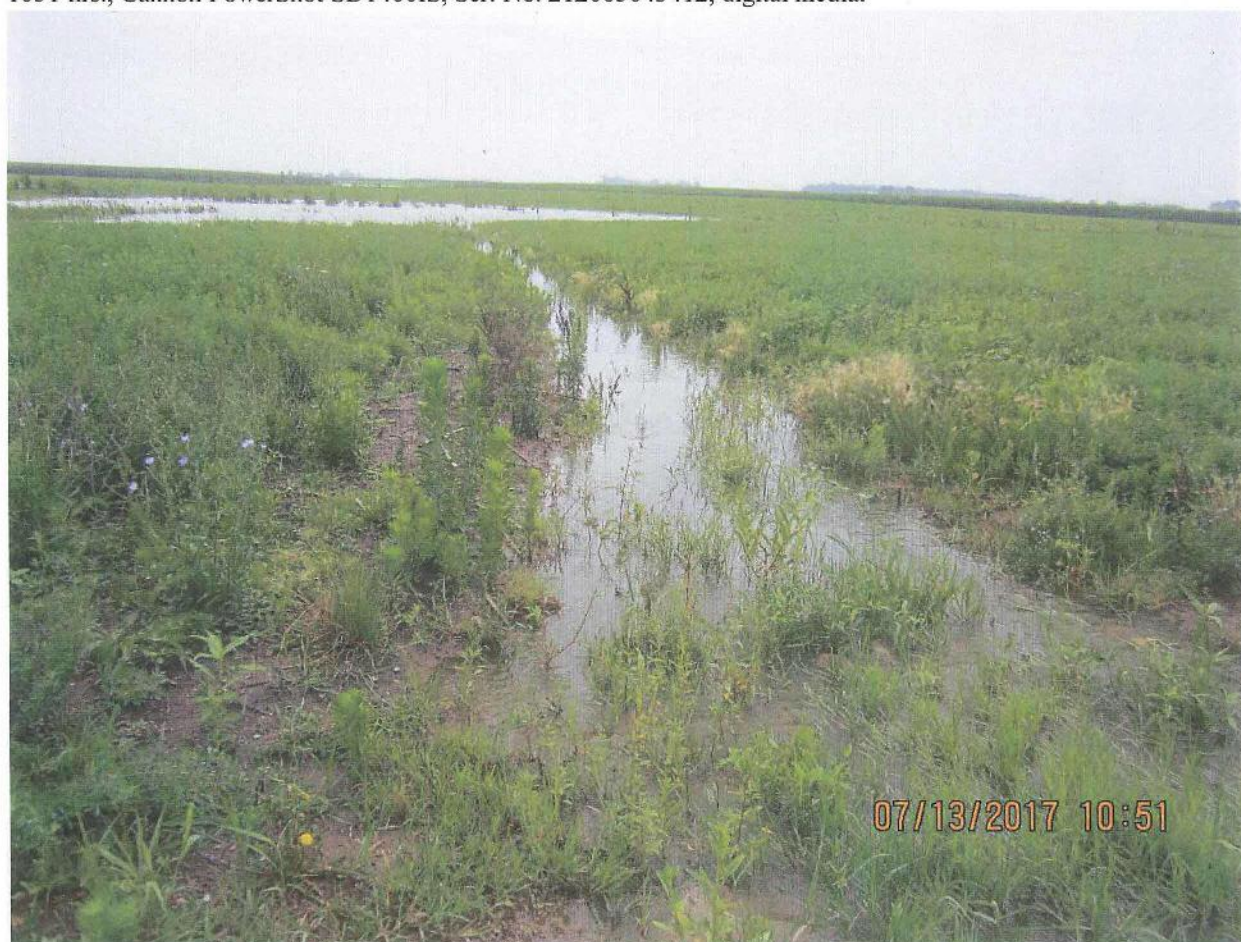
Photograph 6 of 14. Storm water ditch carrying liquid from contaminated storm water pond looking south. JM, 07/13/17, 1051 hrs., Cannon PowerShot SD1400IS, Ser. No. 212065043412, digital media.

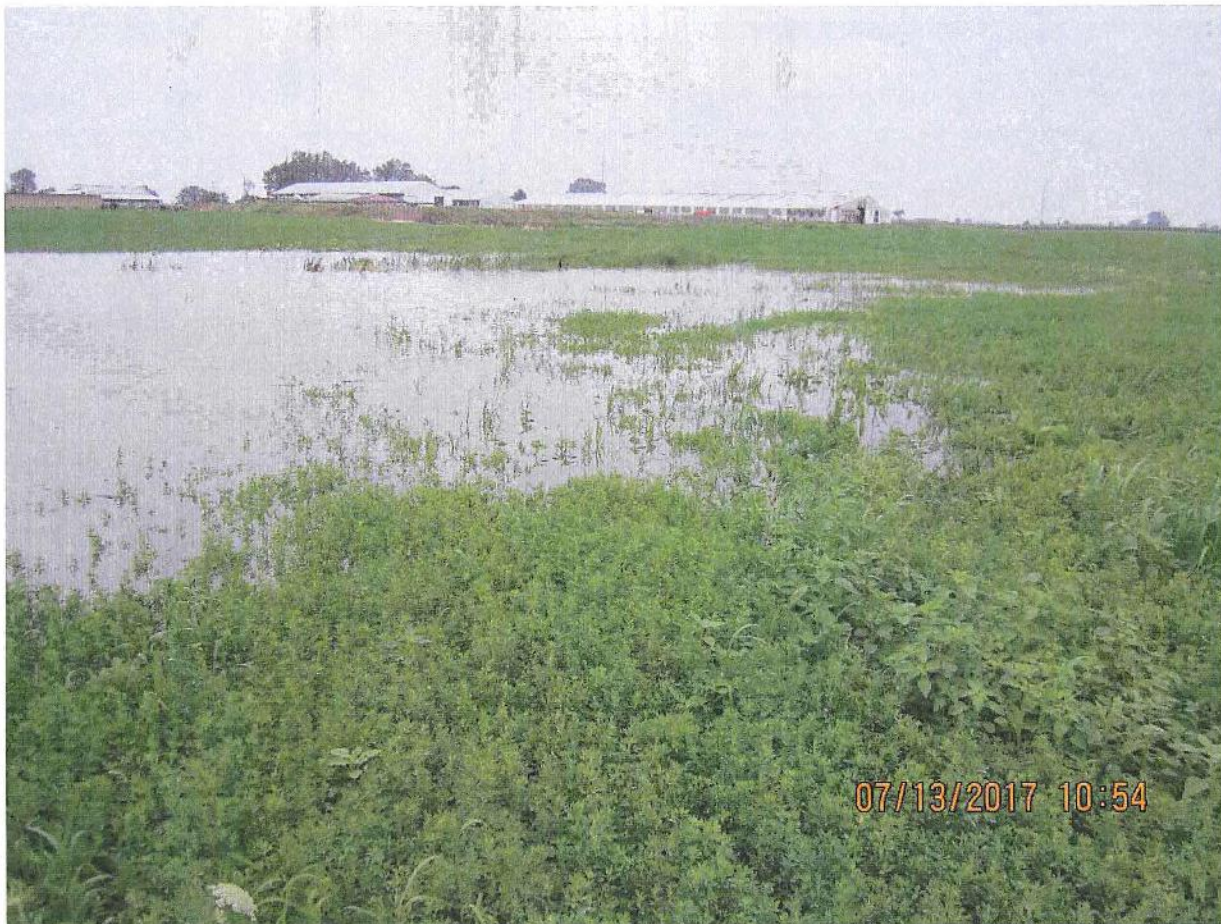
Photograph 7 of 14. End point of ditch in above photographs along south edge of property. JM, 07/13/17, 1054 hrs., Cannon PowerShot SD1400IS, Ser. No. 212065043412, digital media.

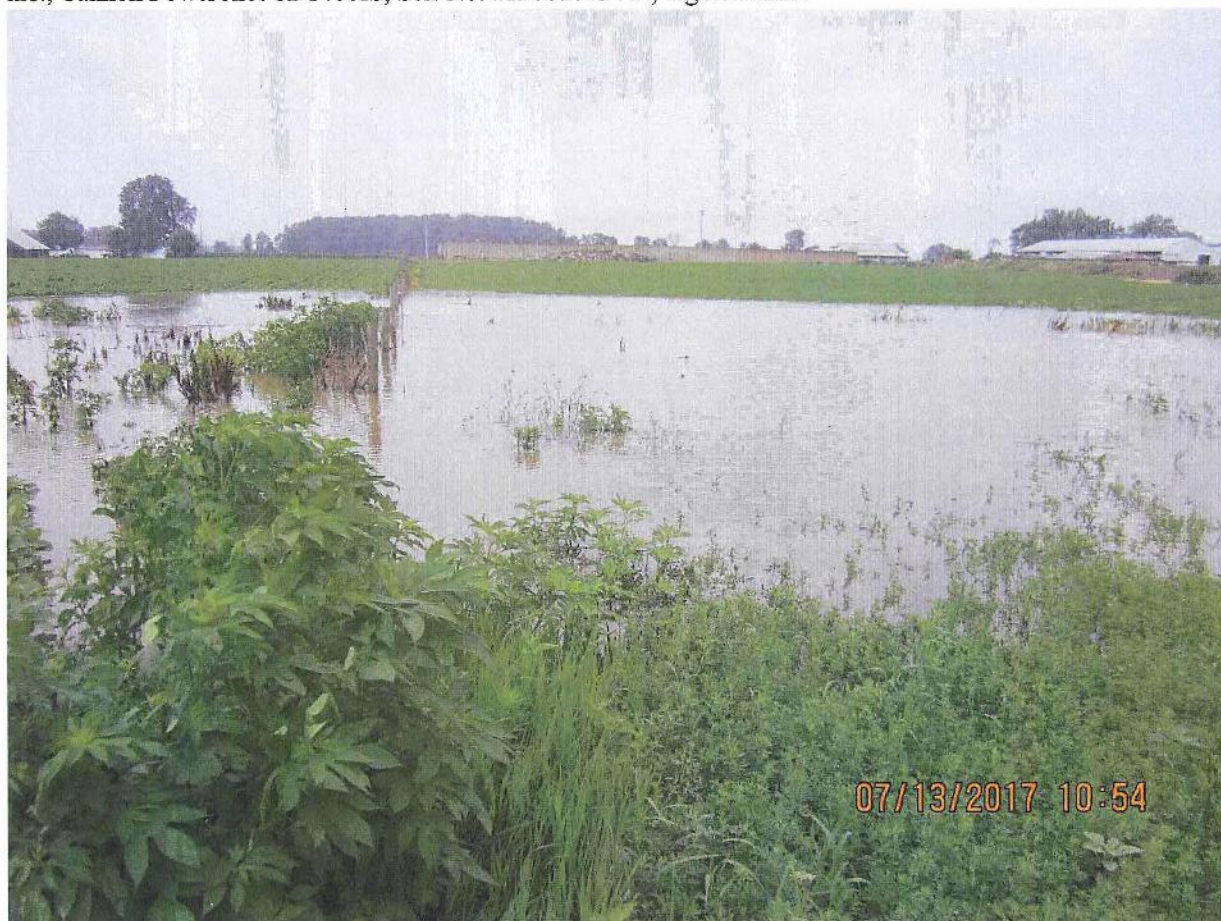
Photograph 8 of 14. Pool of water at end of ditch carrying water from contaminated storm water pond overflow and field runoff. View is looking west. Fence line is edge of Ottawa Holsteins property. JM, 07/13/17, 1054 hrs., Cannon PowerShot SD1400IS, Ser. No. 212065043412, digital media.

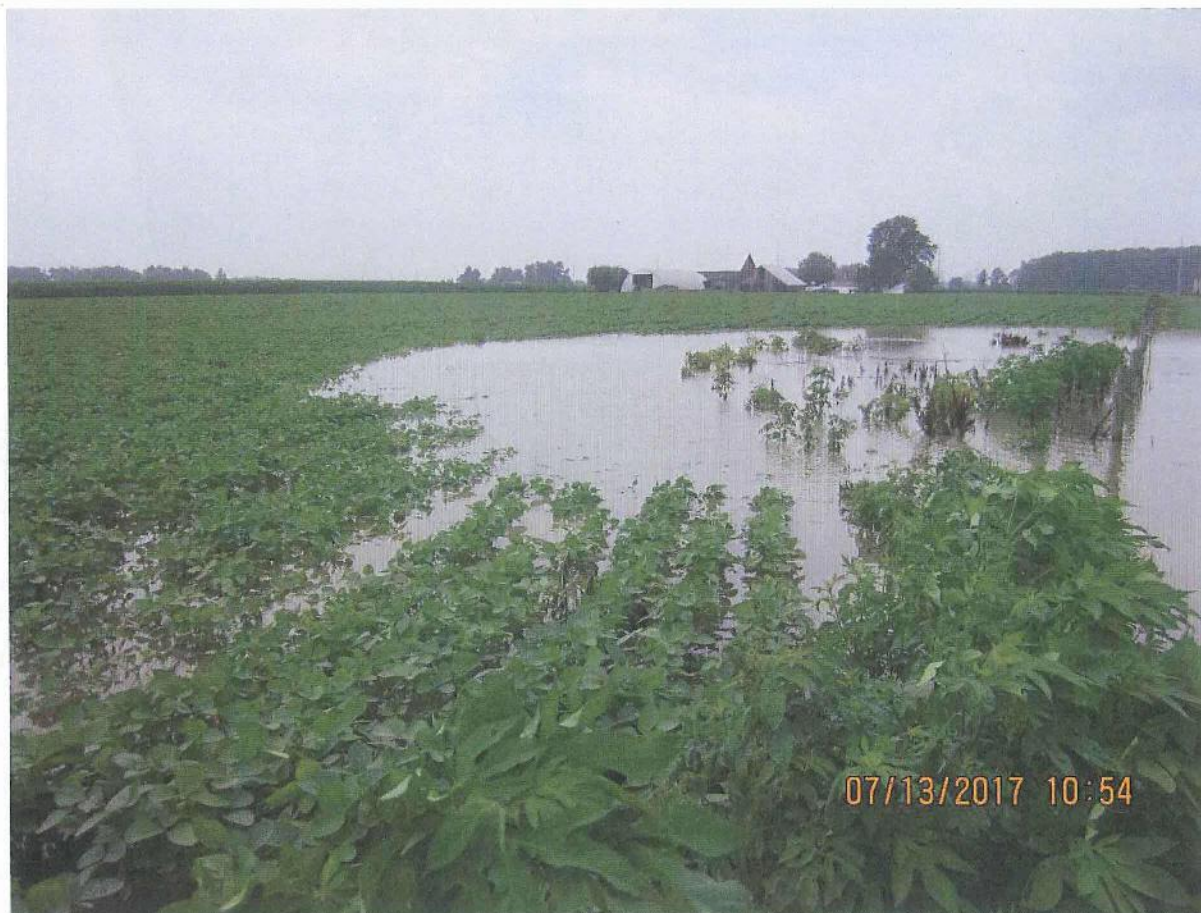
Photograph 9 of 14. Pool of water at end of ditch carrying water from contaminated storm water pond overflow and field runoff. View is looking west/southwest. Fence line is edge of Ottawa Holsteins property. JM, 07/13/17, 1054 hrs., Cannon PowerShot SD1400IS, Ser. No. 212065043412, digital media.

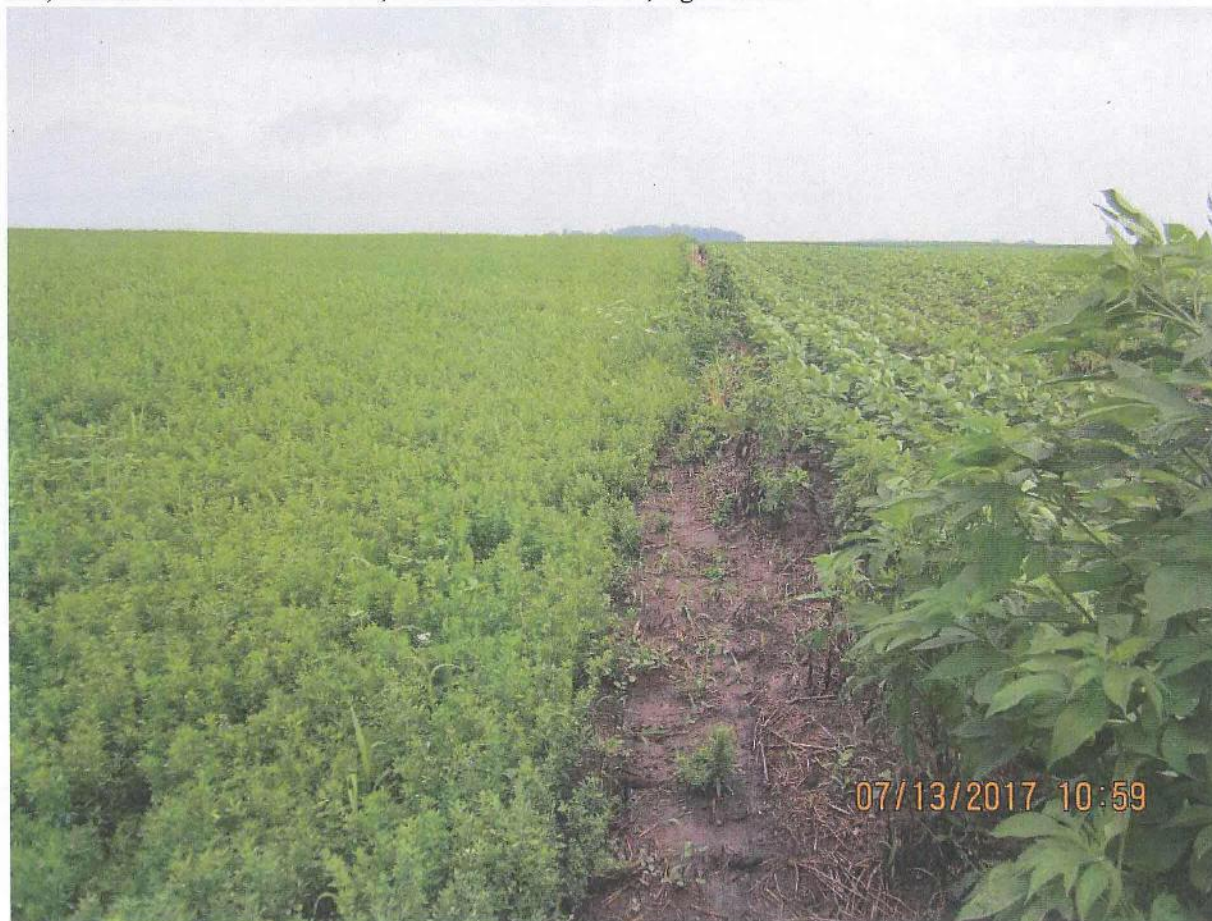
Photograph 10 of 14. View looking east along property boundary (Ottawa Holsteins property to left). Pool of water in photograph 8 is immediately behind photographer. JM, 07/13/17, 1059 hrs., Cannon PowerShot SD1400IS, Ser. No. 212065043412, digital media.

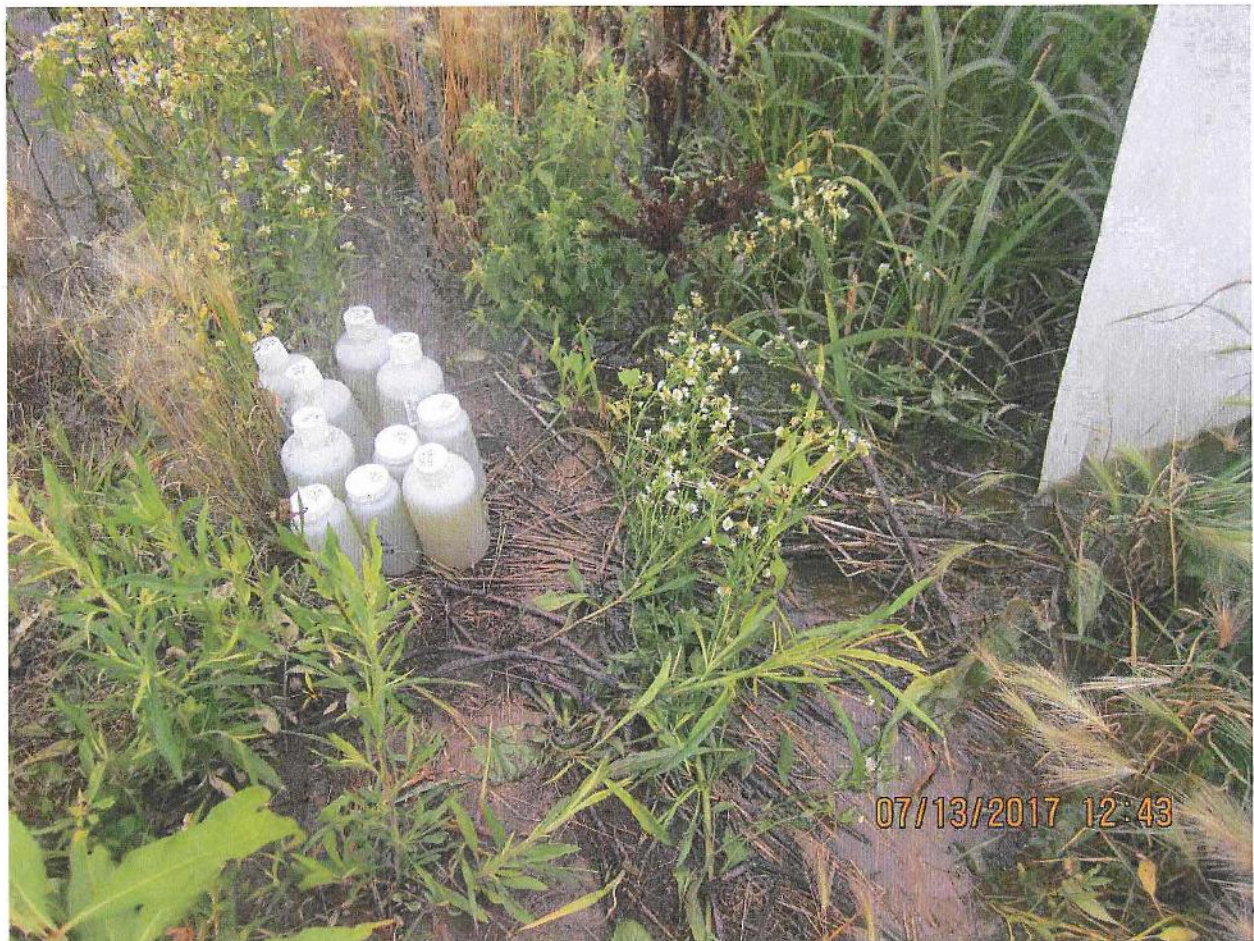
We collected Sample S01 at the outlet point of the contaminated storm water pond. All parameters with the exception of fecal coliform/E. Coli were collected as per the "FY 2017 General Field Sampling Plan". We split samples with the facility. Table 1 in Attachment 4 contains results of field parameters collected with a YSI 556 multi-parameter meter.

Photograph 11 of 14. Sample S01 taken at overflow point of contaminated storm water pond overflow to ditch. JM, 07/13/17, 1243 hrs., Cannon PowerShot SD1400IS, Ser. No. 212065043412, digital media.

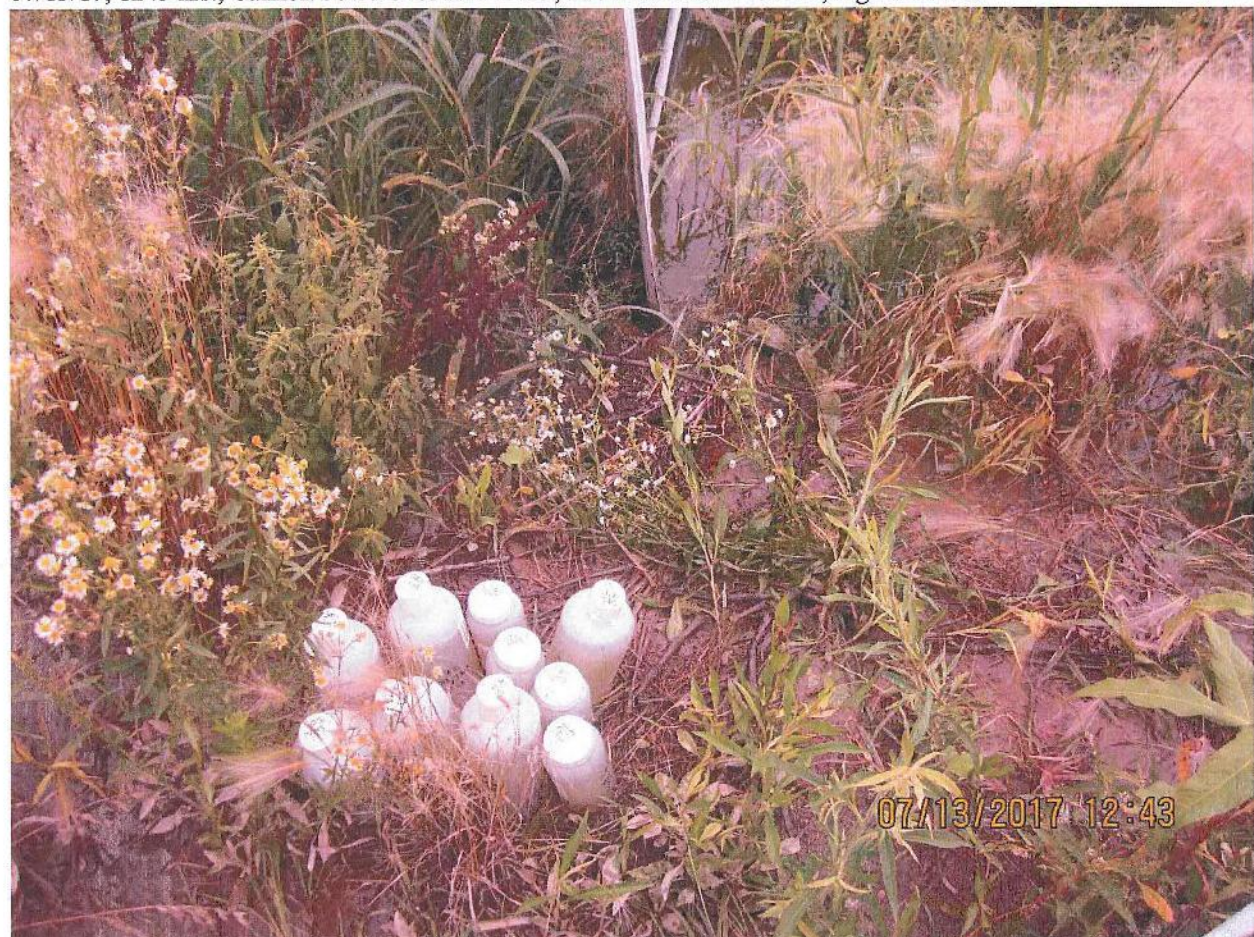
Photograph 12 of 14. Sample S01 taken at overflow point of contaminated storm water pond overflow to ditch. JM, 07/13/17, 1243 hrs., Cannon PowerShot SD1400IS, Ser. No. 212065043412, digital media.

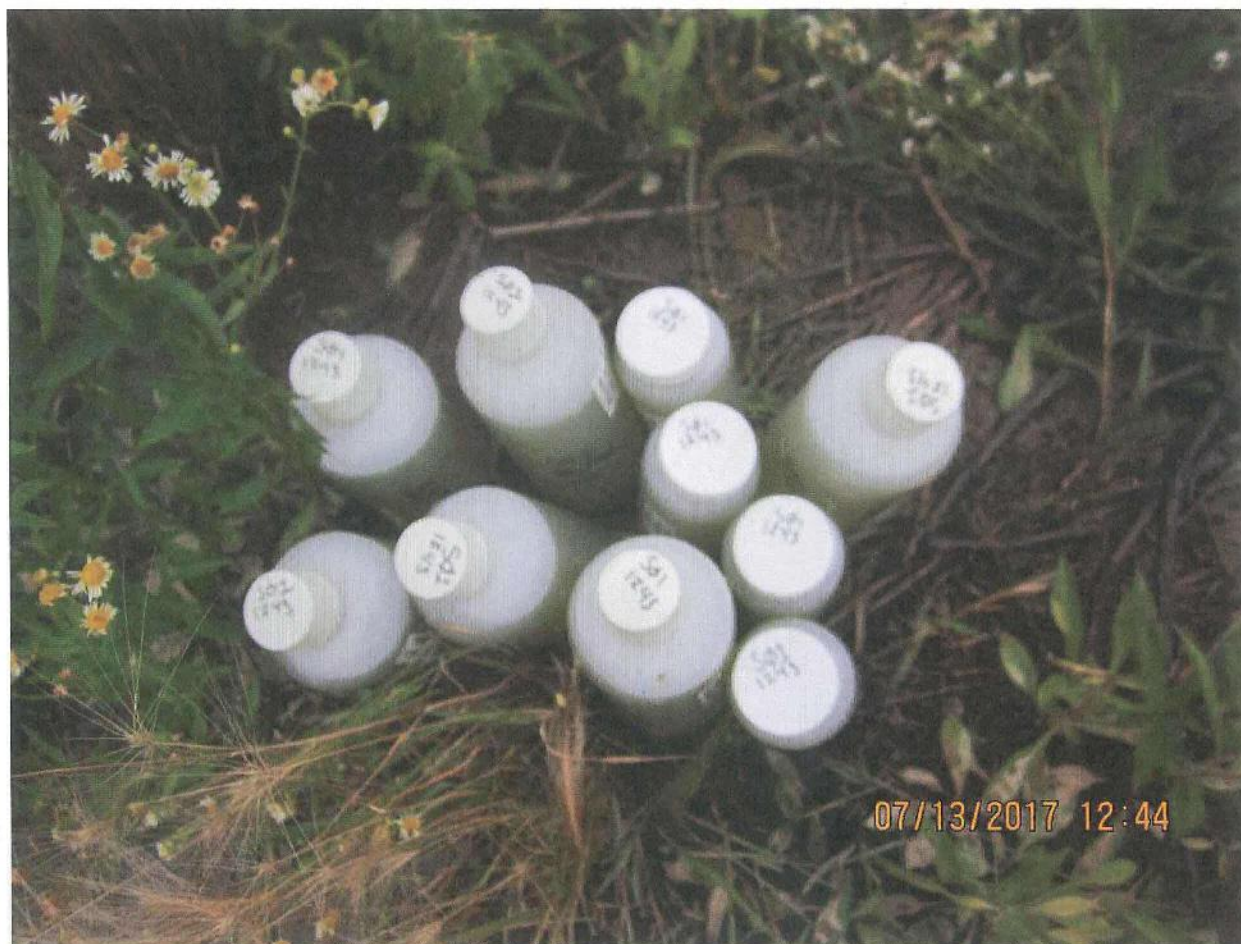
Photograph 13 of 14. Sample S01. JM, 07/13/17, 1244 hrs., Cannon PowerShot SD1400IS, Ser. No. 212065043412, digital media.

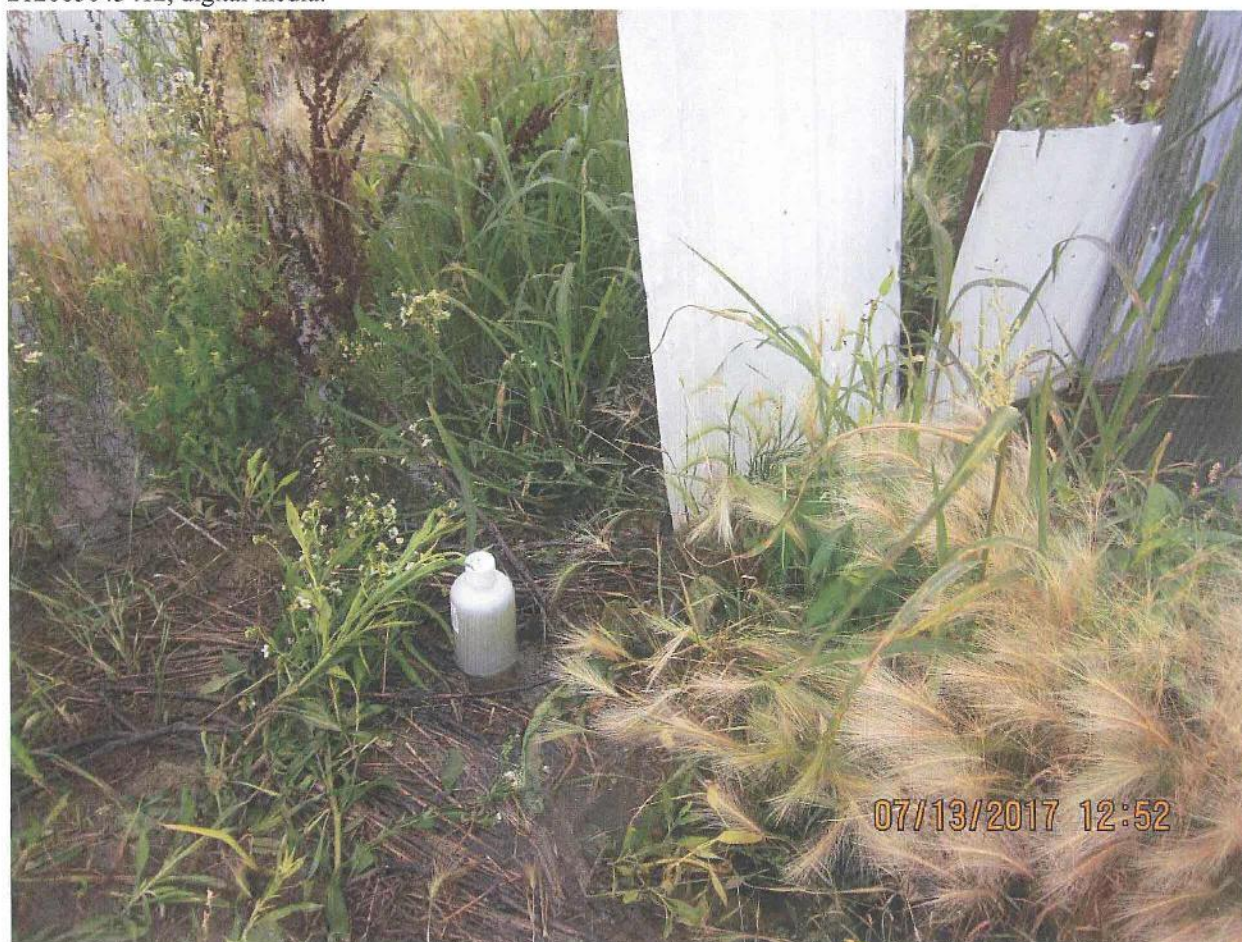
Photograph 14 of 14. Last portion of sample S01 taken at overflow point of contaminated storm water pond overflow to ditch. JM, 07/13/17, 1252 hrs., Cannon PowerShot SD1400IS, Ser. No. 212065043412, digital media.
